# Town of Arlington

## FINAL REPORT

### ADA Self-Evaluation (as basis for Transition Plan)

Prepared by  
Institute for Human Centered Design  
December 15, 2014

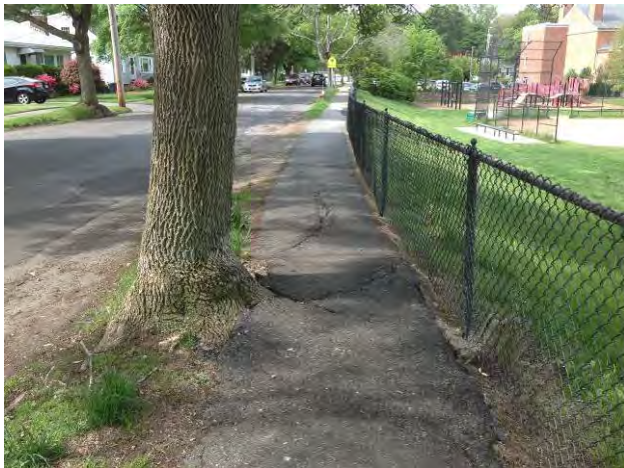
Photo 2

All of the issues described above negatively affect the pedestrian approach to this facility from the nearby public transit stop at Mystic Street @ Columbia Road.

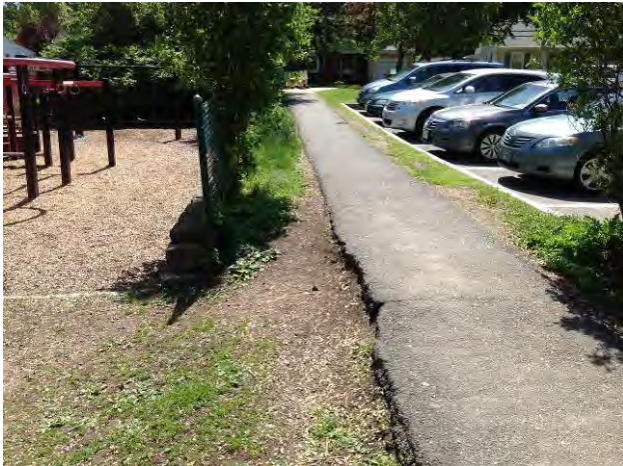
*Photo 5*

There are two points of entry in this facility along Stowecroft Road: one at the parking lot and one near the baseball/little league and soccer fields. The point of entry at the parking lot has an unprotected edge near the playground that is hazardous to those using wheeled mobility devices or who may be unobservant. (Photo 5)

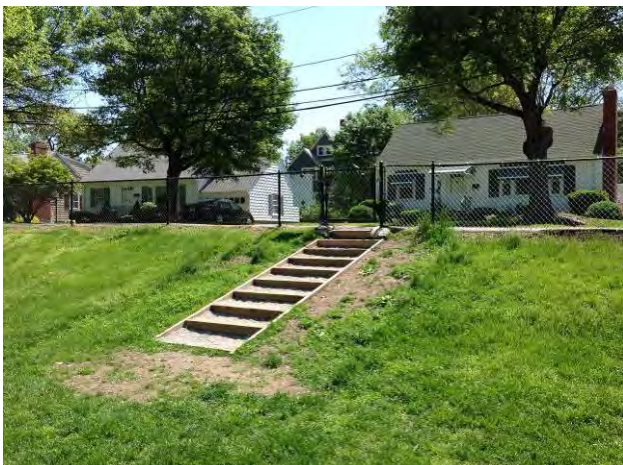
*Photo 6*

Additionally, the stairway leading to the baseball/little league and soccer fields does not have compliant surfaces and railings. Further, this inaccessible point of entry does not offer an ADA-compliant sign directing the public to the accessible point of entry 150 feet away. (Photo 6)

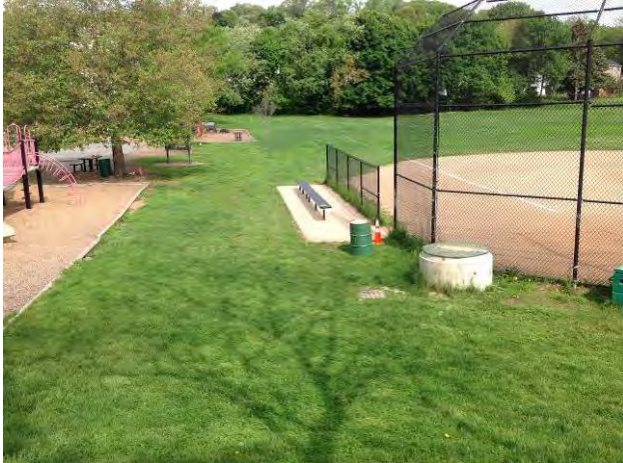
Photo 7

No accessible route is provided to either team seating areas adjacent to the softball/little league field. Although there is enough space for accessible integrated wheelchair seating locations within each dugout, they are not identified by any markings. (Photo 7)

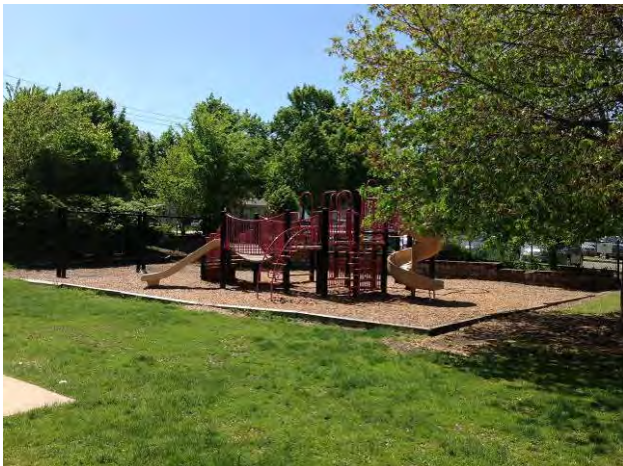
Photo 8

Two playgrounds are provided in this facility: one on the East side of the basketball court and adjacent to the parking lot, the other on the West side of the basketball court. (Photos 8 and 9)

Although the wood fiber surface is currently well maintained and has compliant slopes, no accessible route is provided to the playground on the East side of the basketball court. (Photo 8)

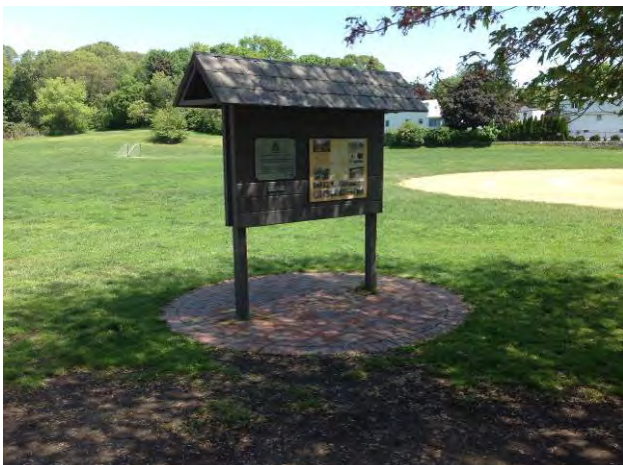
Photo 12

A bulletin board is provided at the edge of the grassy field; however, it is not located within an accessible route. (Photo 12)

Although not a requirement under the ADA, consider extending the asphalt walkway to the bulletin board. The accessible route to this amenity can adjoin the new accessible walkway to the benches.

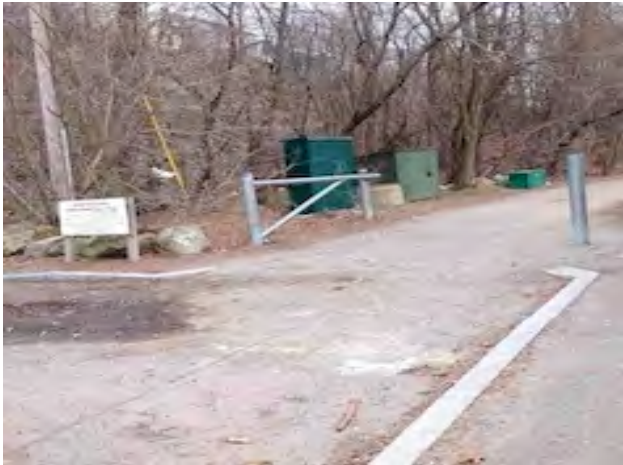
Photo 4

The main entry is not along an accessible route because the route is not firm, stable, level or slip-free. (Photo 4)

There is not at least one accessible route to connect Buck Fields and Hill's Hill facility to the accessible parking spaces, public streets and sidewalks and public transit nearby. These facilities are also not connected via at least one accessible route to the other programs, facilities and public amenities within the Sports Complex. (Photo 4)

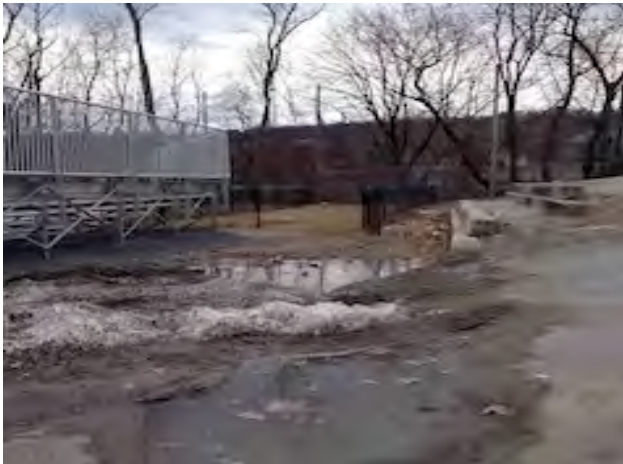
Photo 5

The Batting Practice area approach and entrance is not firm, level or slip free; and it is near old crumbling staircase infrastructure, which provides an additional safety hazard. (Photo 5)

There is not at least one accessible route linking all program areas offered at Buck Field together and to the at-grade entrance. (Photos 5 and 6)

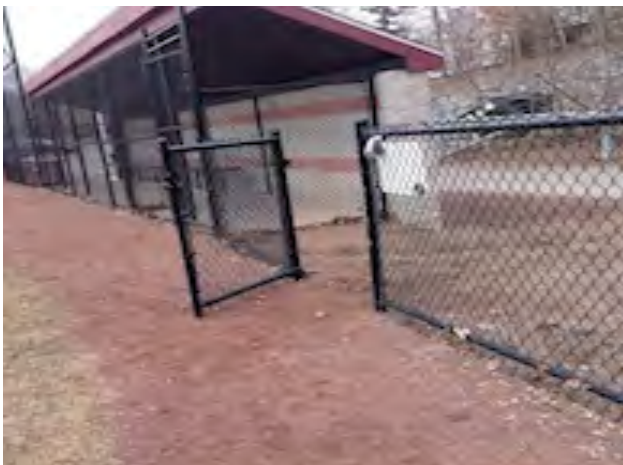
Photo 6

Team Dugout/clubhouse ground surface is a mixture of gravel and hardtop with no paved accessible route available at this time. (Photo 6)

Alterations were completed without provision of an accessible route to and within the clubhouse and team seating areas. (See Photo 6)

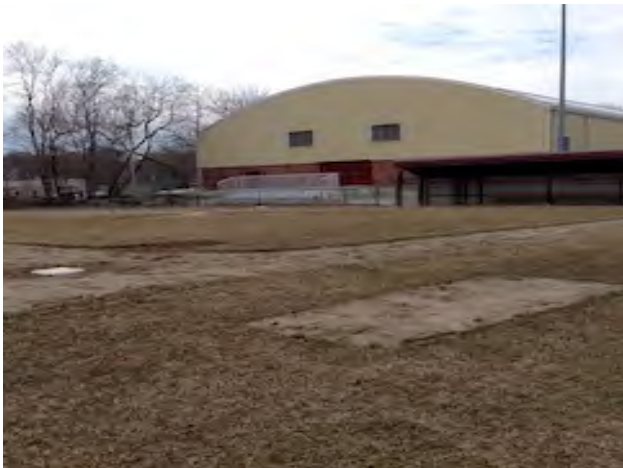
Photo 8

Practice fields within fence have a well graded warning strip; however, there is no connection between fields and at least one accessible walkway within perimeter of facility. (Photo 8)

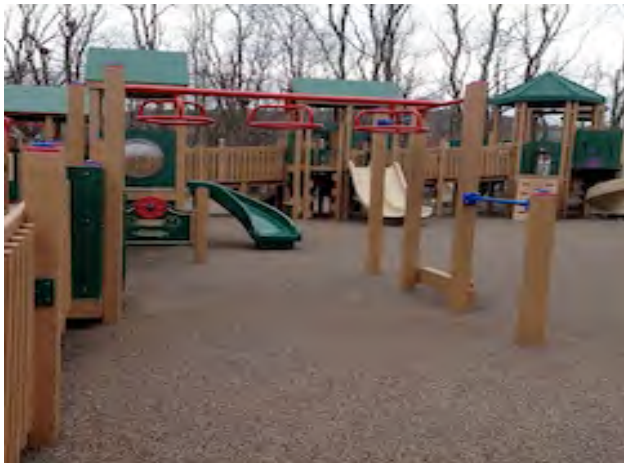
Photo 11

The large accessible composite play structure provides an accessible elevated route to over 90% of the elevated play components and provides many types of exciting and integrated play opportunities along the way. When the accessible route issues are connected between and within these two play areas (i.e., cross slopes not exceeding 2.08%), this playground will indeed be a model of an exciting and integrative program. (Photo 11)

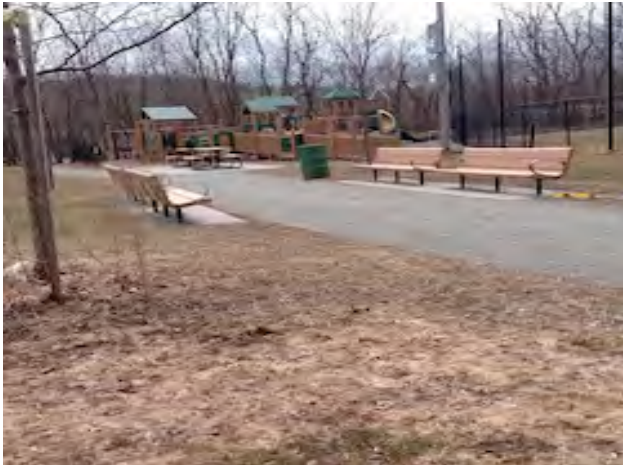
Photo 15

A picnic area with two tables is provided at the front of the playground area and there is a picnic table at the back of the playground area as well, near the fence. There is also a picnic table located outside the fence near the team clubhouse, which clutters an already narrow and excessive sloped route from adjacent parking spaces to facility entrance. There are no accessible tables provided; however, there is adequate level ground space for accessible seating alongside the tables in the front. (Photo 15)

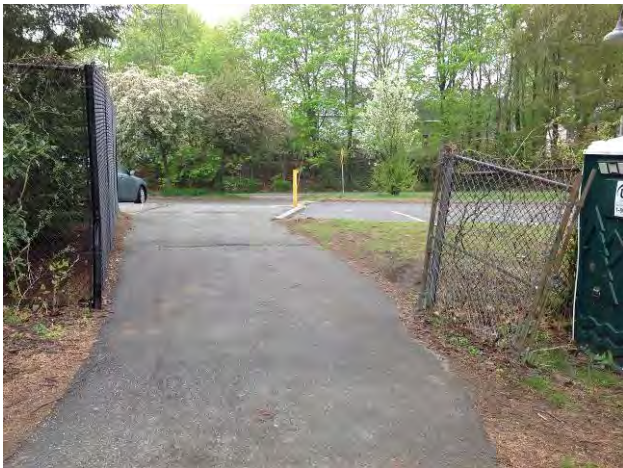
Photo 2

There are two points of entry in this facility: one on Summer Street and one on Russell Place / bike path access point. Both points of entry have walkways with excessive slopes. (Photos 2 and 3)

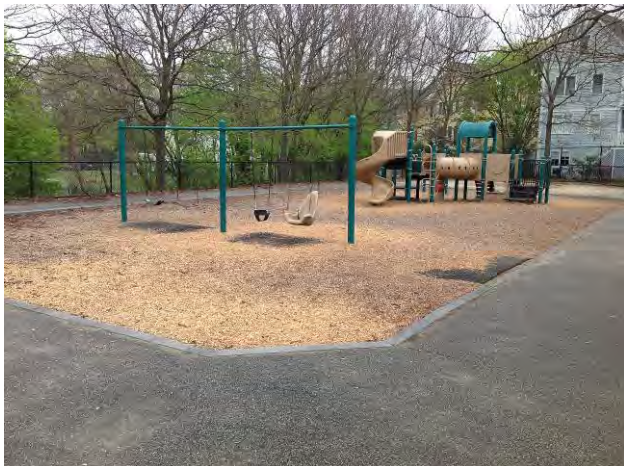
Photo 5

Although the rubber surface extends from the asphalt walkway to a few transfer steps of the play structure, it is not properly maintained and it is covered by wood fiber. Additionally, not all ground play elements are connected to an accessible route. (Photo 5)

Install or maintain an accessible route at, between and around all entry points to ground elements and all exit points at bottom of elevated play components. At swingset area, consider replacing loose fill with unitary surface materials.

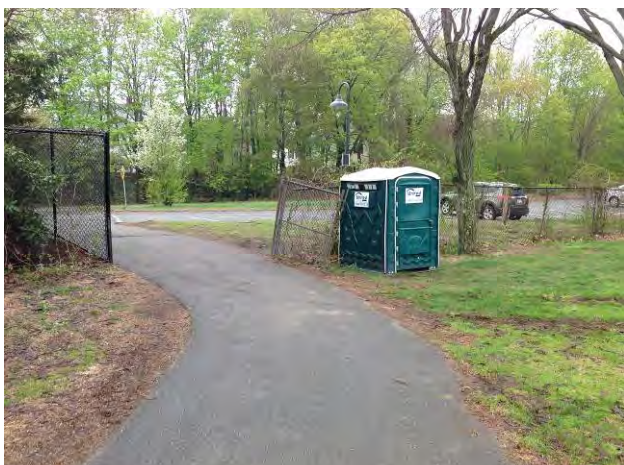
Photo 6

One portable toilet is designated as accessible and is located at the point of entry along the bike path. However, this amenity is not inaccessible because it does not adjoin an accessible route. (Photo 6)

Relocate the portable toilet along the existing asphalt walkway or extend the walkway to it (about 10 feet).

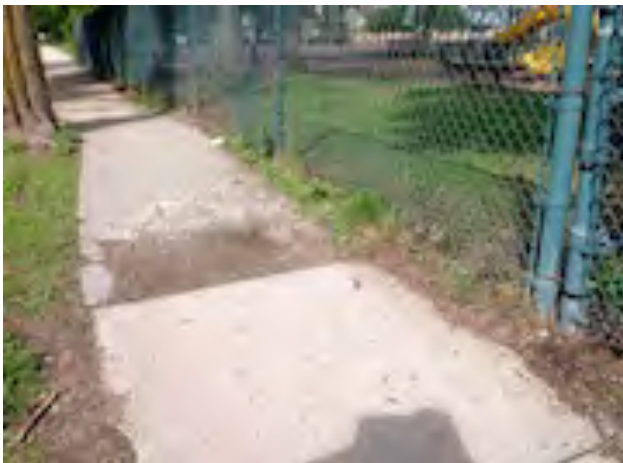
Photo 3

Oxford St. sidewalks are in disrepair with large panel gaps, level changes, varying widths, excessive slopes and not smooth. (Photo 3)

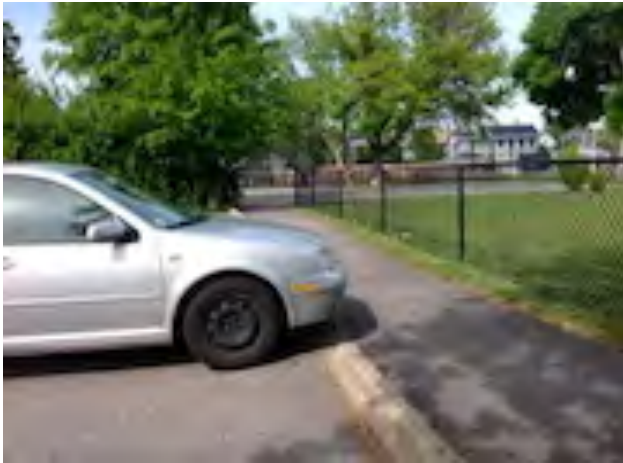
Photo 4

The reserved adjacent parking lot includes a back paved path connected to facility's hopscotch/four-square court and interior walkways. This path requires maintenance for level changes and slope issues. (Photo 4)

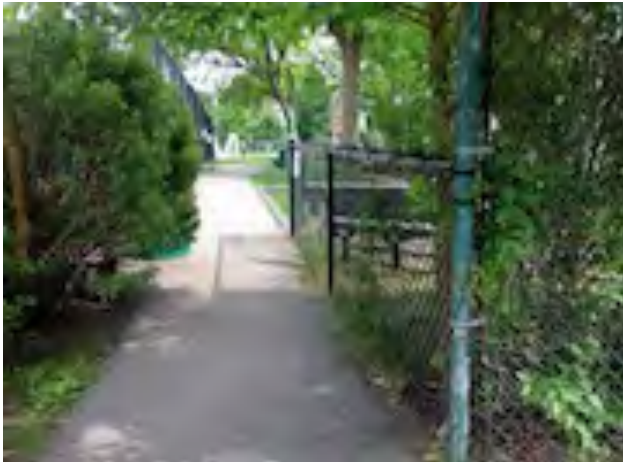
Photo 5

The main facility entrance, with signage, is along Oxford. There are exterior approach and entry sidewalk issues here, including change of level and excessive cross slopes. The interior walkway and entrance is well maintained. (Photo 5)

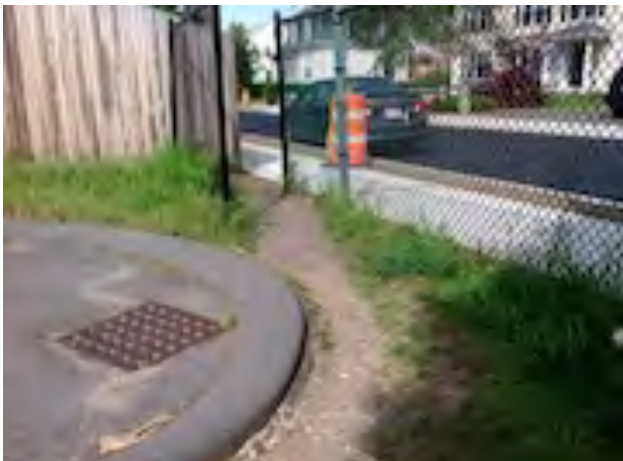
Photo 6

The entry from Oxford is inaccessible and not safe. The entry point is located at a narrow fence opening and includes a dirt path that is narrow, not smooth and level, and that is overlapped by the high level changes inscribing the Basketball/Singles Tennis court area. (Photo 6)

While this entrance from Winter Street remains inaccessible, directional signage should be placed at the sidewalk entrance directing users to the nearest accessible route into facility. (See Photo 6, p. C-26)

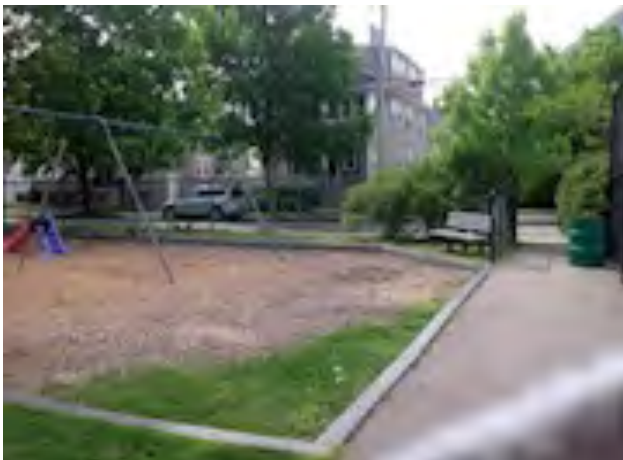
Photo 9

The play area with loose-fill ground surface materials does not include an accessible point of entry due to the border fully surrounding the perimeter of this play area. (See Photo 9, previous page)

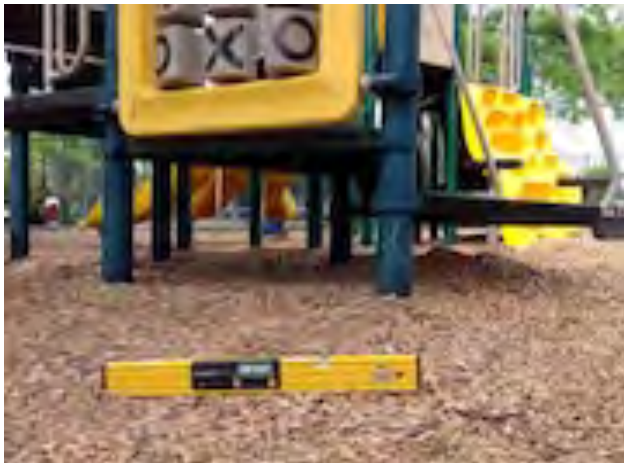
Photo 10

The playground loose fill materials have excessive cross slopes at some entry/exit points, such as at the spring rocker, at the bottom (exit point) of some slides, and at some transfer steps on the large composite structure. These ground surface issues are a current barrier to accessible circulation to and between ground play elements. (Photo 10)

a. If only loose fill ground surface materials are used, a high-frequency maintenance policy needs to be in place to ensure accessibility of ground surface materials in play area use zones through all seasons.

b. If ground surface materials will be replaced: consider adding impact-attenuating tiles within the playground areas to provide accessible routes and clear ground spaces to all entry/exit points of ground play elements, including swingsets, spring rockers and play structure.

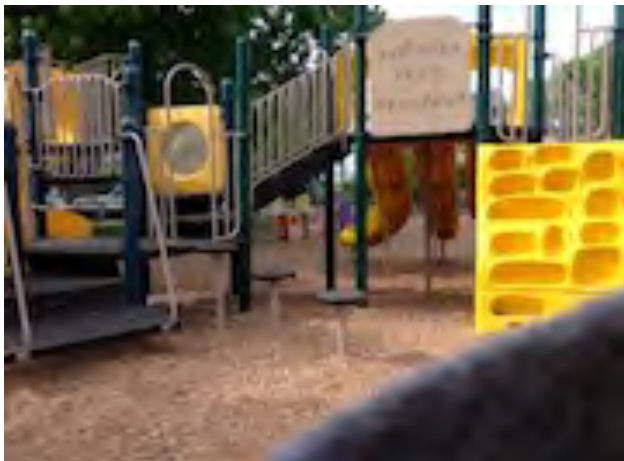
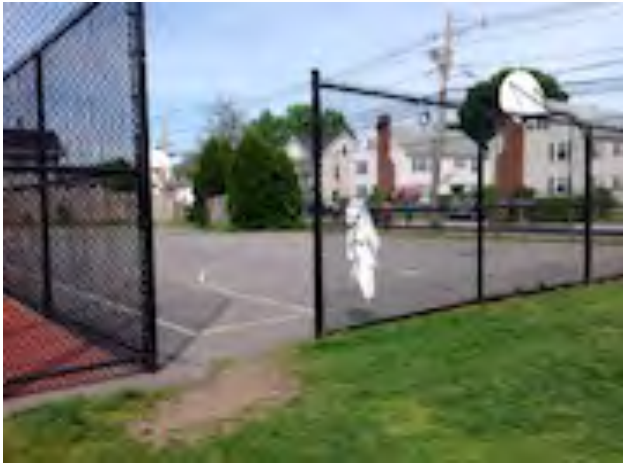
Photo 12

No accessible elevated route to elevated play components is currently provided. (Photo 12)

There is a full Basketball Court and a singles tennis or badminton court located on the Winter St. side of facility. There is no accessible point of entry into and through this area from Winter St. sidewalks, and there is no accessible route to this area from the field. (Photo 12)

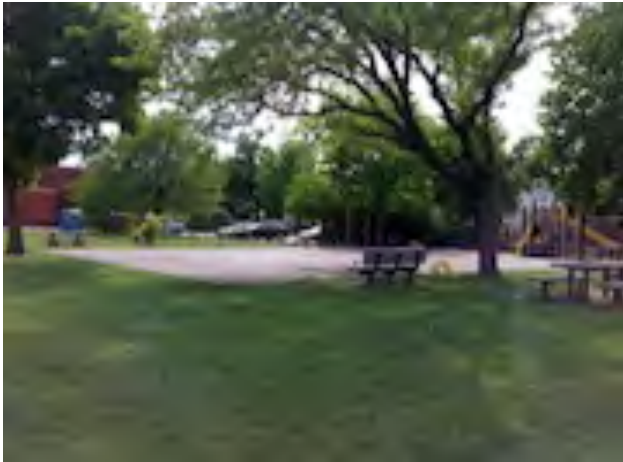
Photo 13

The Open field is one of the Town's scheduled soccer practice fields, and provides a lovely grassy space at other times. Picnic tables are in the field and benches are along the field perimeter. The field is adjacent to the ground games court, which is connected to the accessible interior walkways. (Photo 13)

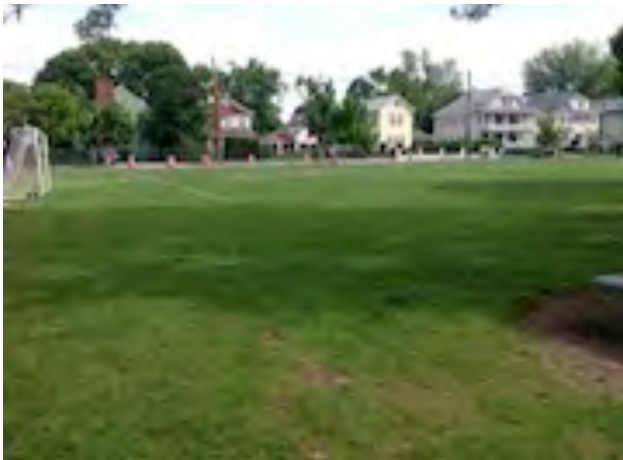
Photo 14

The perimeter of the field play areas and elements and amenities supporting field activities (such as benches, picnic tables and the portable toilet) are not connected along at least one accessible route with the playground, Basketball court, and accessible entrance to facility. (Photo 14)

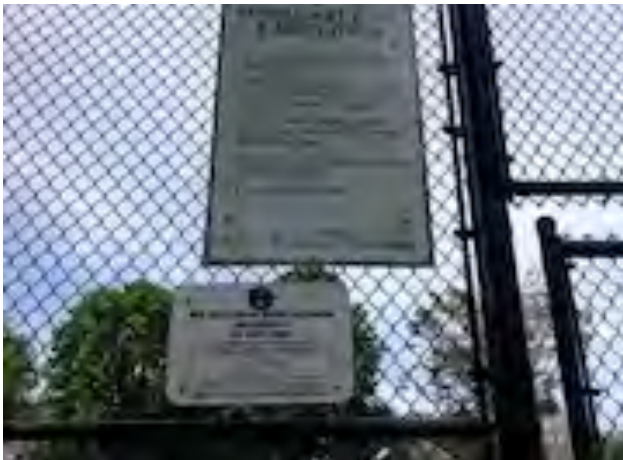
Photo 17

Informational Signage regarding Tennis Court rules is posted on the fence. This information is mounted too high for comfortable viewing. There is no information regarding how to obtain this information in alternate accessible formats. (Photo 17)

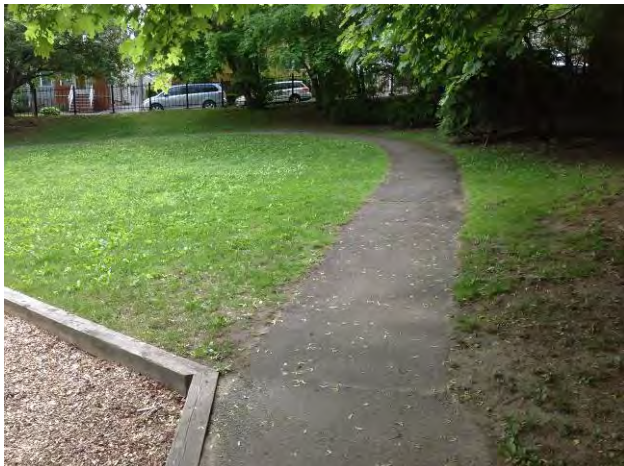
*Photo 5*

Although the asphalt walkway surrounds the playground, it does not extend to all transfer points of the play structure. (Photo 5)

Remove a portion of curb along the perimeter of the playground and replenish or replace the ground surface so that it is flush with the adjacent walkway.

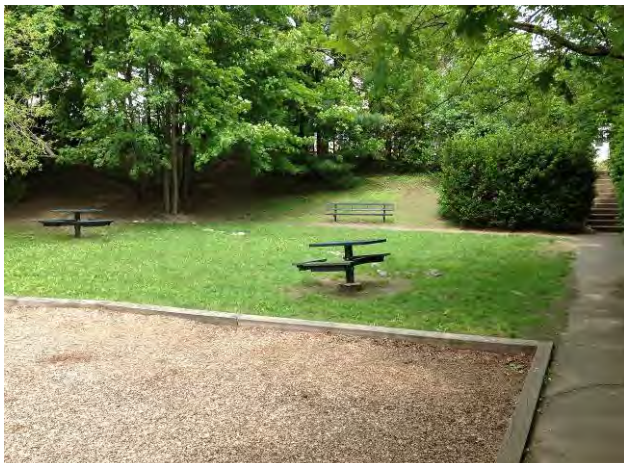
*Photo 6*

Three four-top tables are provided between the playground and the entrance at Robbins Road. Although one table provides the required knee clearance for wheeled mobility devices, it is not offered along an accessible route. (Photo 6)

- 5 Tables:** Extend the asphalt walkway to the table designated as accessible.

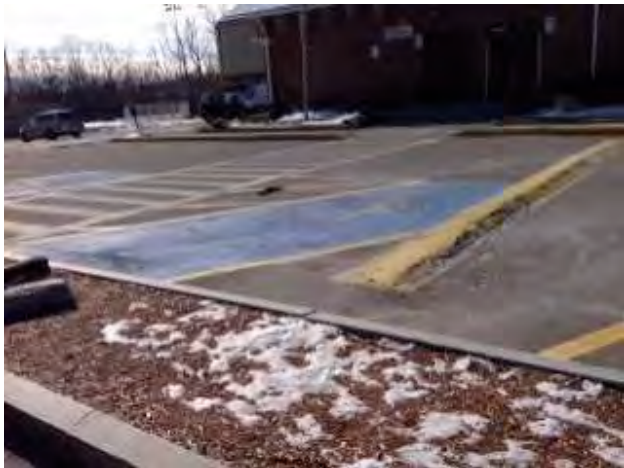
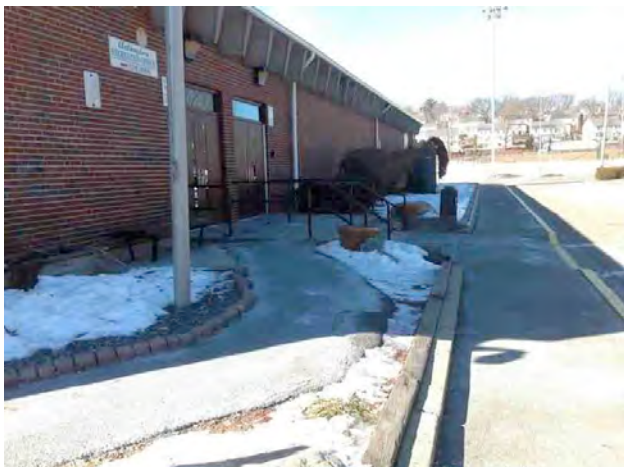
Within the parking facility used for Arena programs and for Buck Field/ Hill's Hill programs, there are two marked crosswalks located at the access aisles adjacent to the designated accessible parking spaces. These crosswalks do not provide an accessible route connection from parking spaces to the entrance, because they lead to inaccessible sidewalks and curb cuts. (Photo 2 and 3)

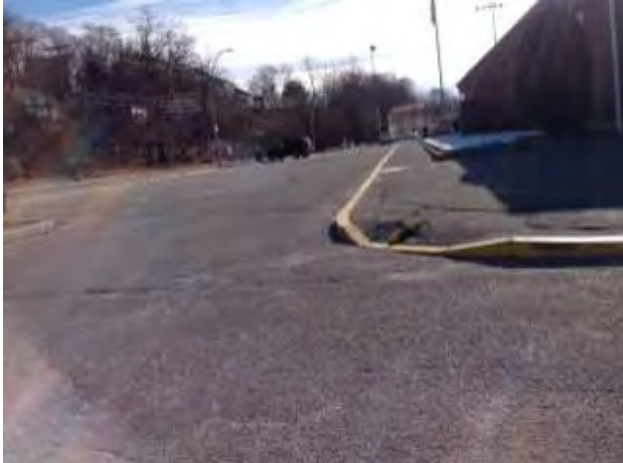
Photo 4

The apex curb ramp at the facility sidewalk facing Summer St. Park is inaccessible, with steep running slopes, excessive cross slopes, and missing flared sides. The gutter and sidewalk transitions have excessive changes in level. Curb ramp is unusable. Due to its excessive slopes, water and ice accumulation are probable. (Photo 4)

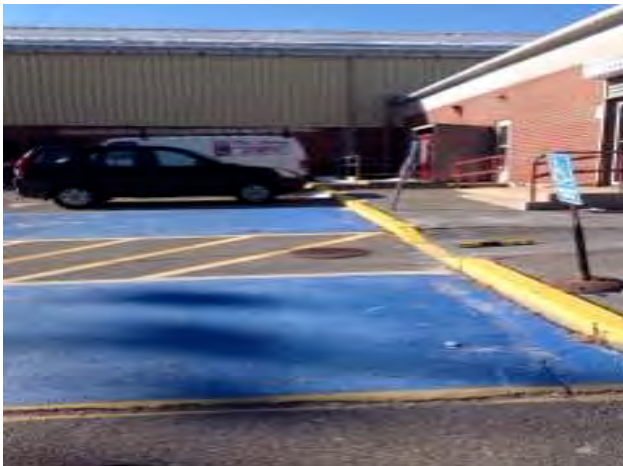
Photo 5

The two curb cuts located within the parking lot connecting the designated accessible parking spaces to facility perimeter sidewalk are located at the shared access aisles between two designated parking spaces. These curb cuts, similar to the curb cut facing Summer Street Park, have no usable features. Water and ice accumulation are probable. When crossing these curb ramps to move along the sidewalk between the Recreation Department Office on the side to the front Arena entrance doors, individuals are faced with extreme dips and rises in the sidewalk. These inaccessible curb ramps require redesign and reconstruction to come up to code. (Photo 5)

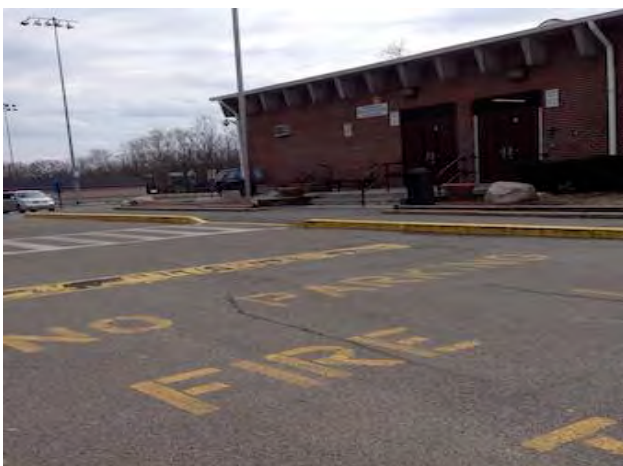
Photo 6

The facility is surrounded on three sides with a walkway that does not provide accessible connections to the parking lot crosswalks, the entrance doors, the Arena emergency exit doors, or the ramp that leads into the Recreation Department office. This inaccessible sidewalk has warped, uneven surfaces and requires redesign and reconstruction to come up to code. (Photo 6)

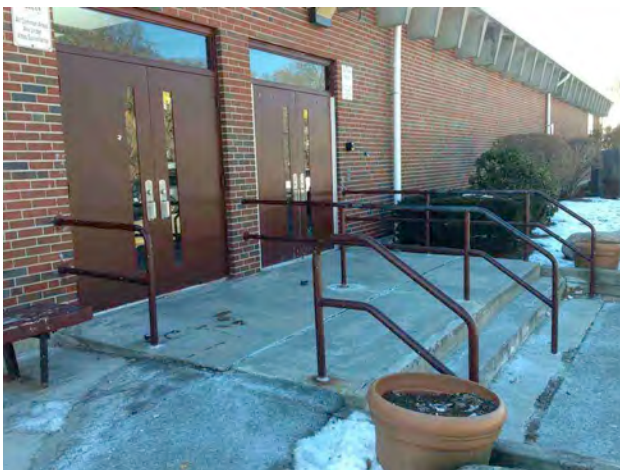
Photo 9

Facility has one public entranceway area with two sets of double doors, and a 3-step stairway with divider handrails. The no-step entrance is along a walkway from side parking area, leading to only one set of doors. (Photo 9)

Inaccessible entrances require directional signage and accessible entrances require an International Sign of Accessibility (ISA) at the entrance. Recommendation is to redesign entryway to provide access at both sets of doors; and to ensure that at least one accessible route links all facilities, programs, elements and amenities outside and inside the entire Complex.

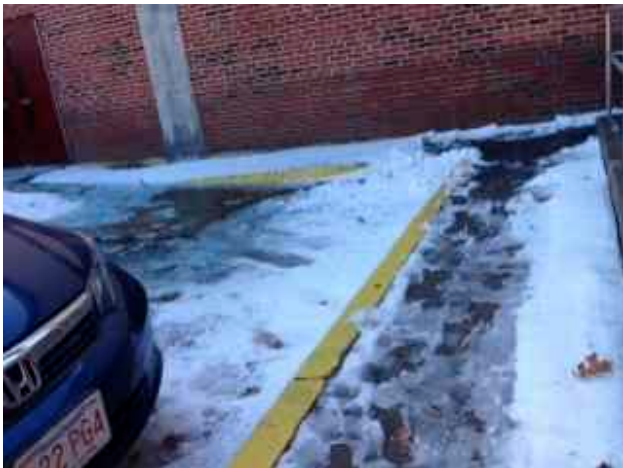
Photo 11

Within the Arena there are at least four doors for emergency exit, but only one leads to a no-step area. This area does not include an accessible route from the door to the facility walkway or to the parking lot. Snow, slush, water and ice removal are important items to include on a routine maintenance list for the parking lot and the designated accessible emergency exit area.

There needs to be redesign and construction of a code-compliant emergency egress route at this Arena parking facility location. The route should not overlap with parked cars and needs to be continuously accessible, leading to an area of safe refuge.(Photo 11)

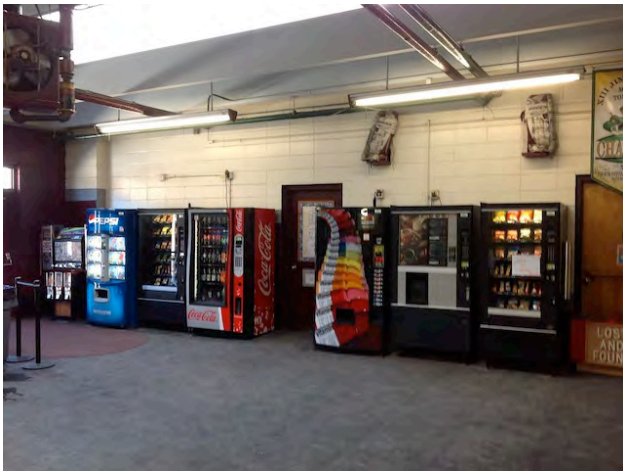
Photo 14

The location of the vending machines at the entrance area may create a crowded and impassable condition during spectator events. (Photo 14)

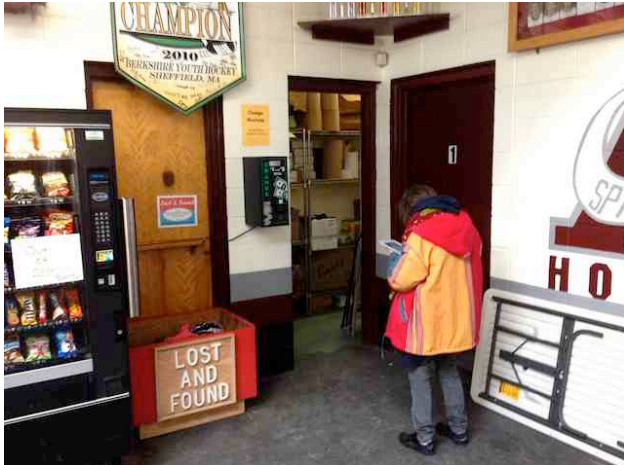
Photo 16

The Main Room/Lobby area also contains multiple tripping hazards<sup>15</sup>, which include:

- Floor mats at entrance, which need to be securely fastened to minimize tripping hazards;
- Folding board signage and pole signage;
- Lost & Found box, which has an edge, not aligned with side edge of adjacent Vending machines. (Photo 16)

- Securely fasten floor mats at Lobby entrance.
- Replace floor mats within Arena circulation paths that are in the general path of travel and/or in the path of travel to emergency exit doors where the edges are higher than 1/2 inch, beveled. Securely fasten all mats.
- Relocate folding board signage and pole signage to be outside the path of travel.
- Relocate Lost & Found box to an area where it does not protrude into the path of travel-- including at doors and rooms where the public receives services.

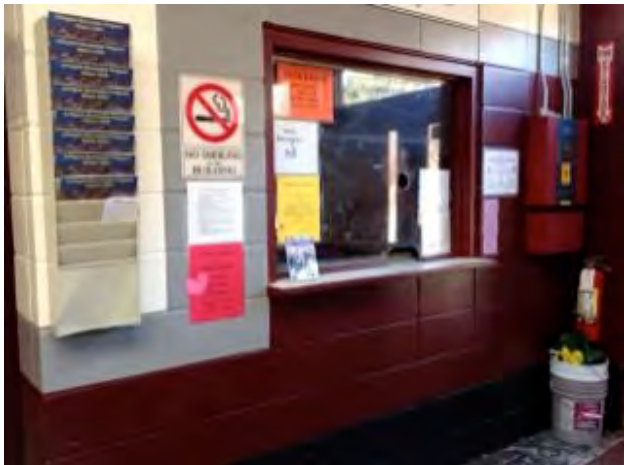
Photo 17

The Equipment Rental/Ticket Counter at Entrance is not accessible because the counter is too high. (Photo 17)

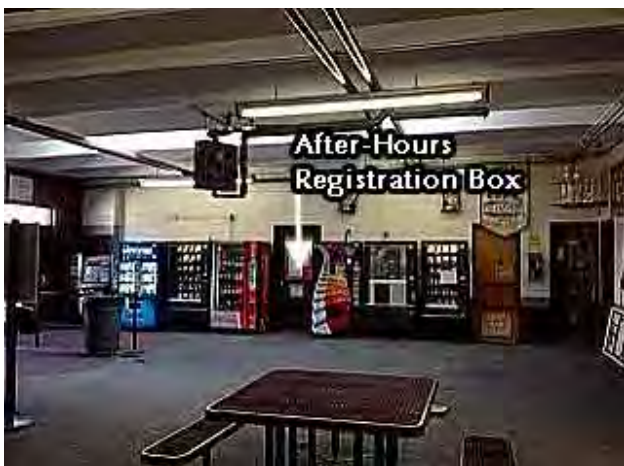
Photo 18

The Recreation Office After-Hours Drop-Off box located on the Department door between the 4th and 5th vending machines is not accessible because it is within a shallow recessed area that does not provide for unobstructed clear floor space for forward or parallel approach. (Photo 18)

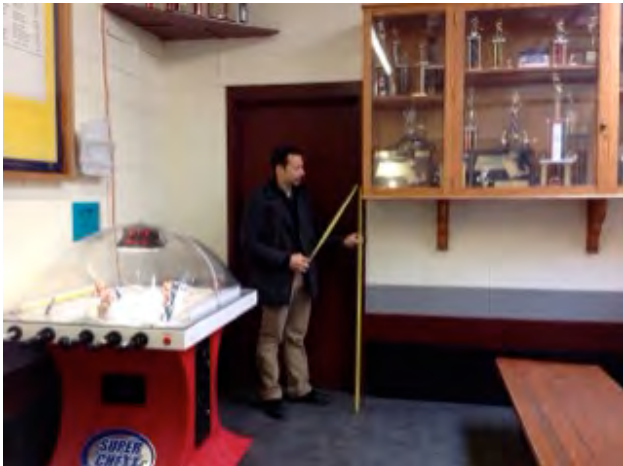
Photo 20

The **foozball game** is not accessible because there is not enough clear floor space for forward or parallel approach. (Photo 20- also shows protruding object measurement.)

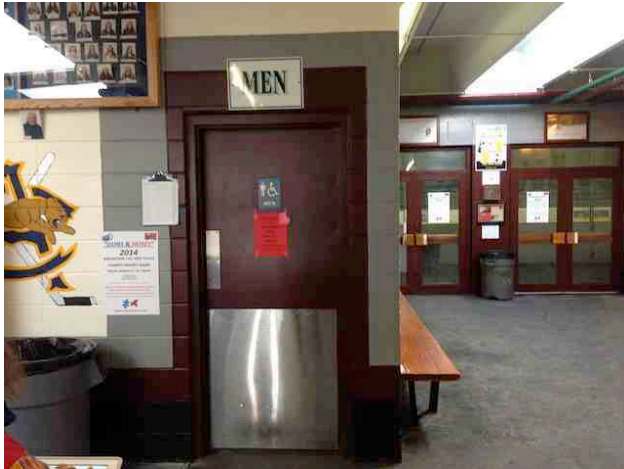
Photo 22

Access to the Women's and Men's Room doors is impeded because of multiple protruding objects against the walls. (Photo 22)

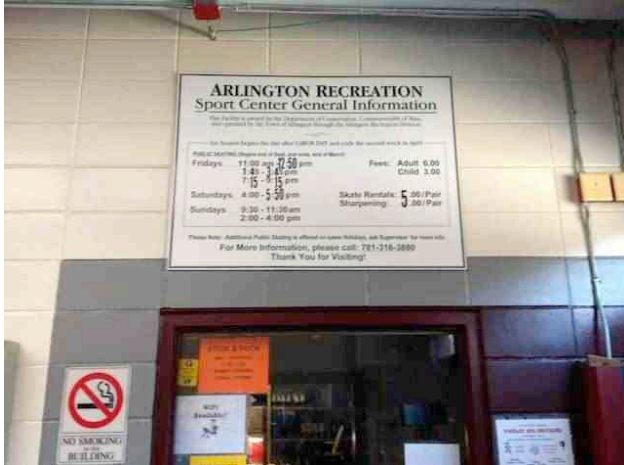
Photo 25

At the entrance and throughout the Main Room, multiple signs give a cluttered appearance. Important signage regarding facility and services information is mounted too high. (Photo 25)

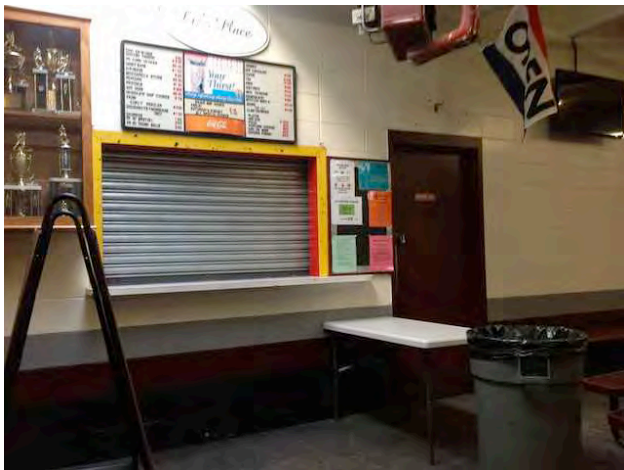
Photo 26

Snack Bar Menu is also not mounted within viewing range. It is recommended to have alternate format menus readily available upon request. This includes Large Print formats. (Photo 26)

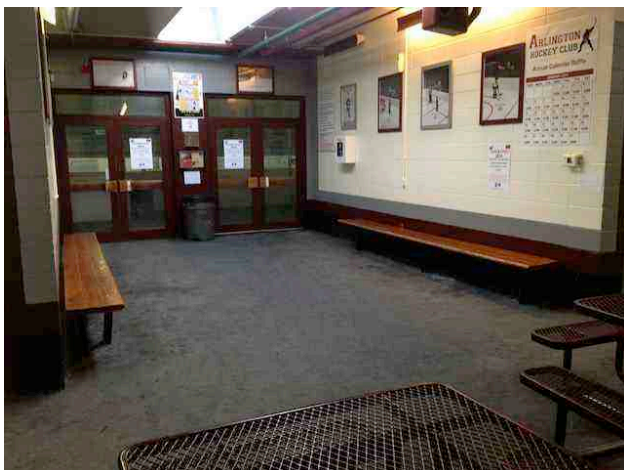
Photo 27

From the Main Lobby to the Sports Arena, benches on either side and a box located on the wall act as protruding object because there is no protection or barriers to allow visually impaired persons to detect these barriers within the route. (Photo 27)

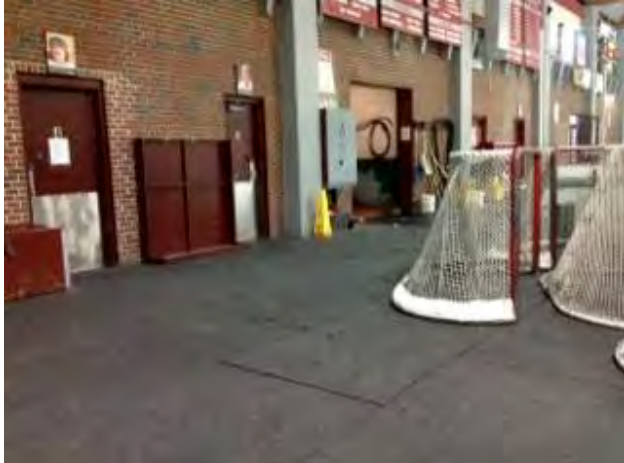
Photo 28

Multiple objects against walls protrude over 4 inches into the circulation route. All objects that are mounted on walls between 27 - 80 inches from floor with no floor-to-bottom detectable shielding need to be made cane-detectable, with shapes that align pedestrians along general public circulation paths. (Photo 28)

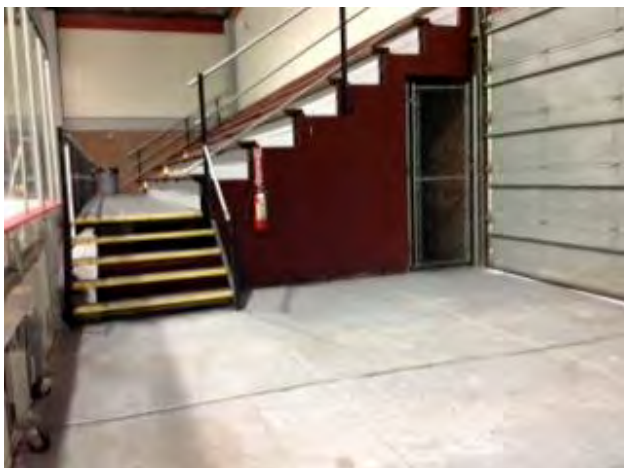
Photo 30

There are no signs designating Team Benches and Bleachers. An area to the right of the rink is separated from the rest of the fixed spectator seating and may be an area used for team meetings. (Photo 30)

Wheelchair seating areas need to be an integral part of all seating plans, including where teams gather, meet and function together. The wheelchair-accessible seats should adjoin the accessible route that also serves as a means of accessible egress in case of emergency.

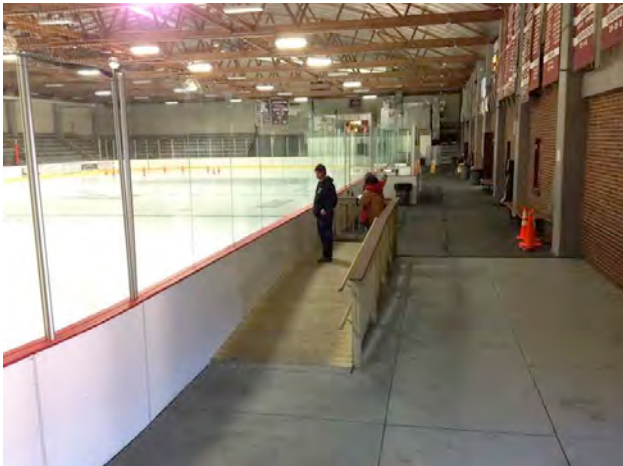
Photo 32

A small ramped platform was recently constructed to seat three wheelchair users in a row, completely separated from the spectator seating area, and unsafe for the users during any emergency. While this may have been designed with an unobstructed view as a goal, such segregated seating is specifically prohibited by the ADA. (Photo 32)

Accessible seating locations may be located at ends of sections, as long as they are adjoining an accessible route and provide access to all public areas, elements and amenities within the general path of travel to the maximum extent possible. At least one companion seat must be provided next to each wheelchair seating location. Moveable seating may be part of this arrangement. (Photo 33)

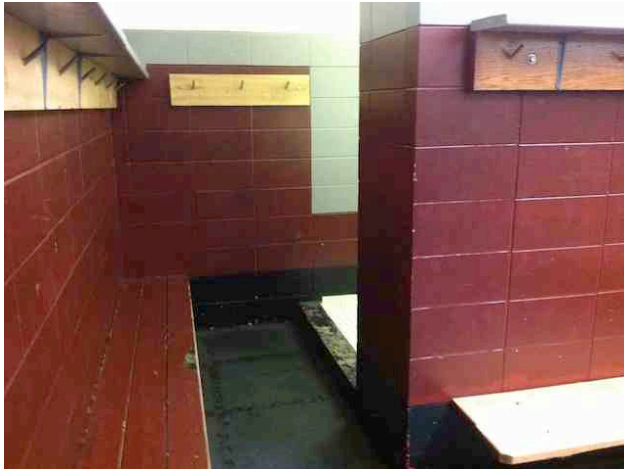
Photo 34

The Skating Rink Arena includes an M & F Team Dressing Room w/ wall benches, hooks and 3-Shower stalls. (Photo 34)

- There is no clear floor space for wheelchair seating and dressing within the wall-mounted bench areas,
- The hooks are higher than 48 inches above the floor and lack minimal 30 inches by 48 inches clear floor space,
- The shower stalls and washing areas have entry ledges that are higher than a beveled 1/2 inch maximum height, and
- The wall-mounted bench seats are not between 17-19 inches above the floor.

The threshold between outside and inside the locker rooms is a tripping hazard and needs to blend with the circulation route with no more than a 1/2 inch beveled transition.

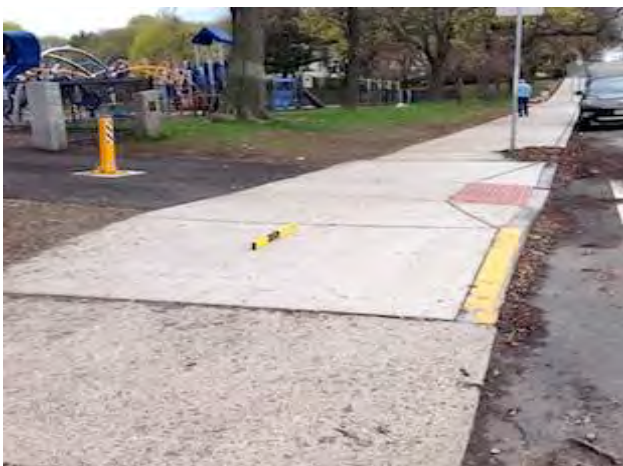
Photo 3

Eastern end of new sidewalk does not blend to compliant slopes where it meets the sidewalk pedestrian zone in front of the school drive-in area (now used for a Four-Square court). (Photo 3)

a. -Where reconstructed sidewalk meets existing new sidewalk panels, evaluate and replace existing sidewalk panels that have noncompliant cross slopes. (at least 6 sidewalk panels, 5 x 5 ft.)

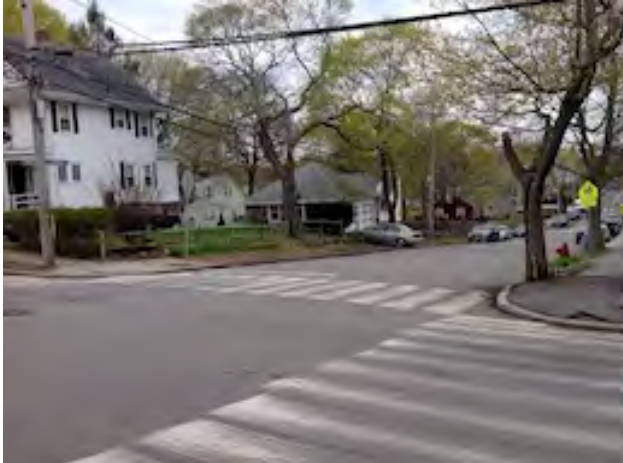
Photo 4

Crosswalks, curb ramps and sidewalks from this location to the new sidewalk panels are in disrepair, inaccessible, and/or missing. (Photo 4)

An accessible route needs to be provided that connects with the nearby public transit bus stop at intersection of Florence Ave. and Wachusett Ave..

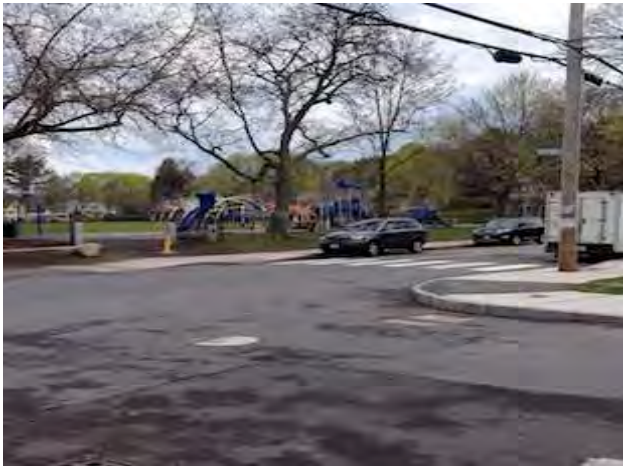
Photo 5

The Renfrew crosswalk entry point includes a walkway with noncomplying slopes. (Photo 5)  
The east entry from school has excessive run slopes.

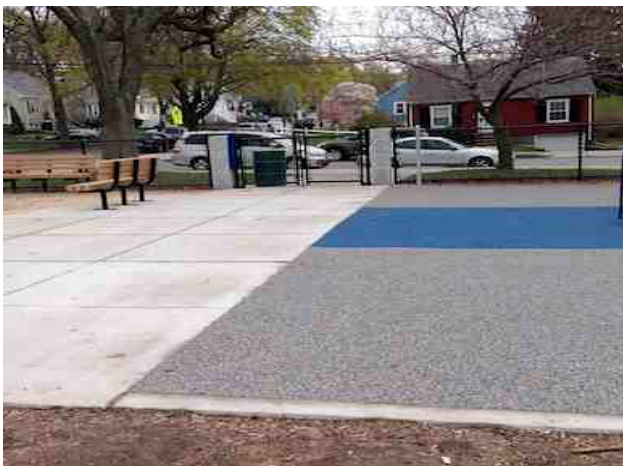
Photo 6

The swinging gate at the Waverly St. entrance now requires a smooth surface on the push side extending the full width of the gate. (Photo 6)

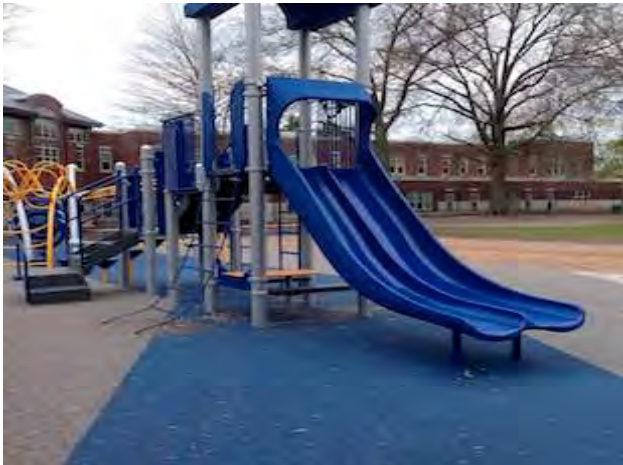
Photo 10

The wood fiber surface under the swingsets is currently well maintained with compliant slopes. The poured rubber "circuit route" allows unrestricted and accessible access to the transfer steps on the play structures and to all ground play elements. This route also connects walkways at both entry points.

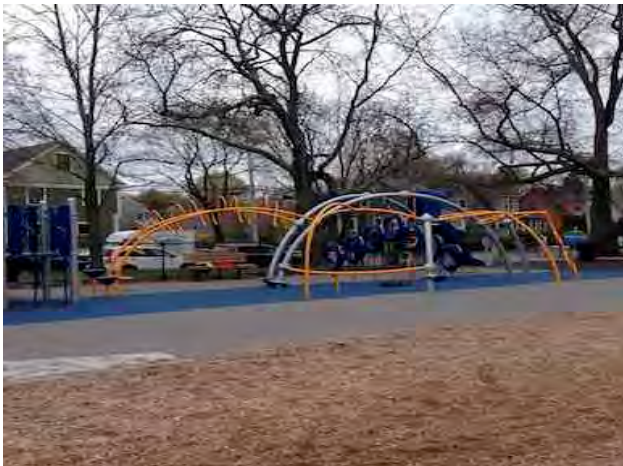
Photo 11

Neither composite play structure includes an elevated accessible ramp. Both structures include transfer stations that provide stepped access to over 50% of elevated play components.

The climbing and swinging structures and the distinctive zip line are play elements for children 5+ that do not provide accessible opportunities. (Photo 11)

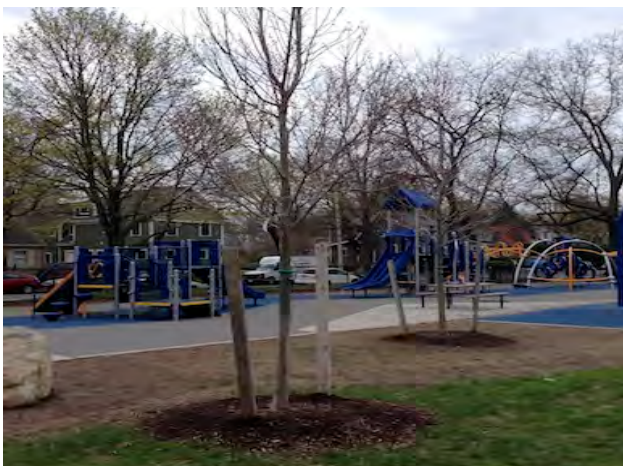
Photo 15

There are 2 game tables at the entryway and one is accessible, plus another larger table with clear space provided for a person using a wheeled mobility device. (Photo 15)

All tables are located along an accessible route.

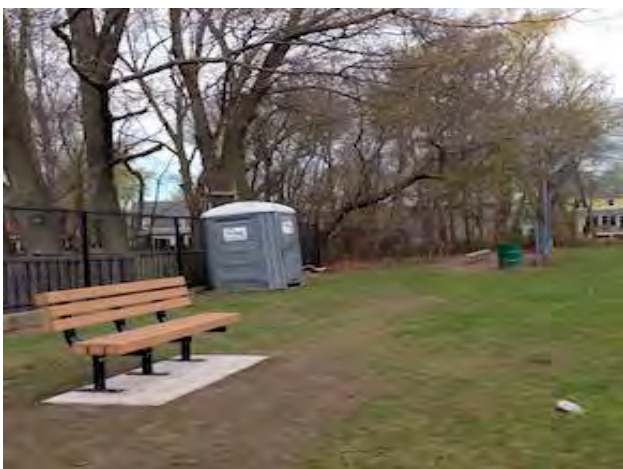
Photo 19

Portable toilet has accessible dimensions but is not located along an accessible route. The threshold height is excessive due to a slight tilt of the amenity. (Photo 19)

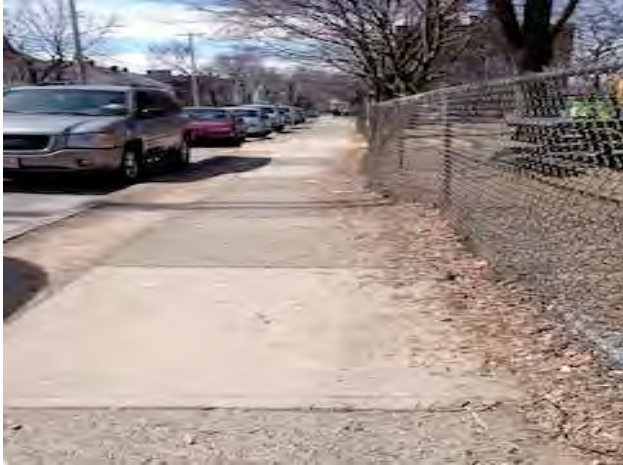
Photo 4

The sidewalks along perimeter of facility on Tufts Street have excessive cross slopes, level changes, gaps and discontinuous surface materials that produce an uneven terrain. (Photo 4)

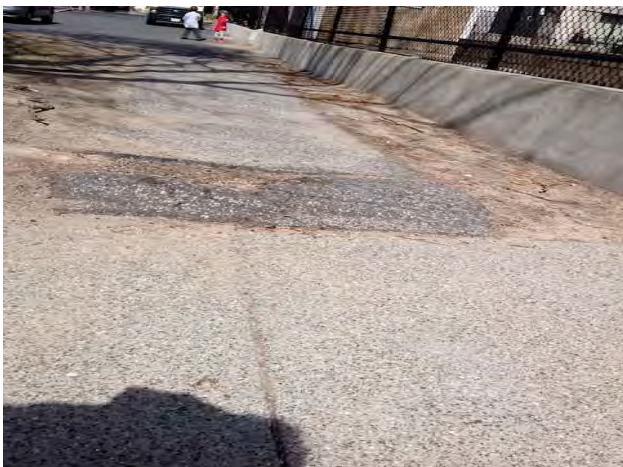
Photo 6

There is no accessible route connecting parking lot to facility accessible entrance. (Photo 6)

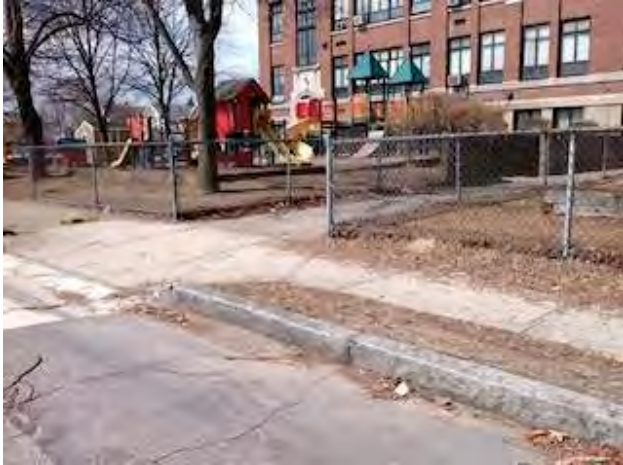
Photo 7

The accessible ramp leading to accessible entrance along Tufts Street needs signage at least as conspicuous as signage at inaccessible entrance. (Photo 7)
